## P158

**STAMPING** P 158 1960

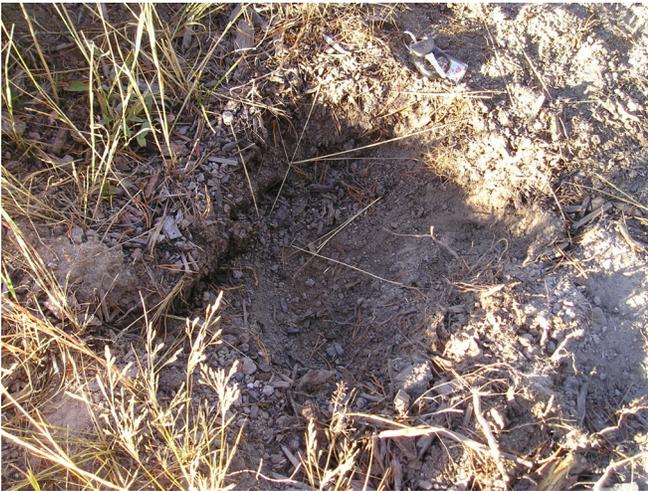
In 2003 the bench mark was searched for and not found, presumed destroyed. A square indentation in the ground is present where the NGS description says the concrete post should be; therefore, it seems likely that the post and bench mark have been removed.

Square indentation where concrete post into which the bench mark was set probably used to be located.
